Applied Surface Science (2012). 259, 674-684. DOI: http://dx.doi.org/10.1016/j.apsusc.2012.07.096

Microstructure and elevated-temperature erosion-oxidation behaviour of aluminized 9Cr-1Mo Steel

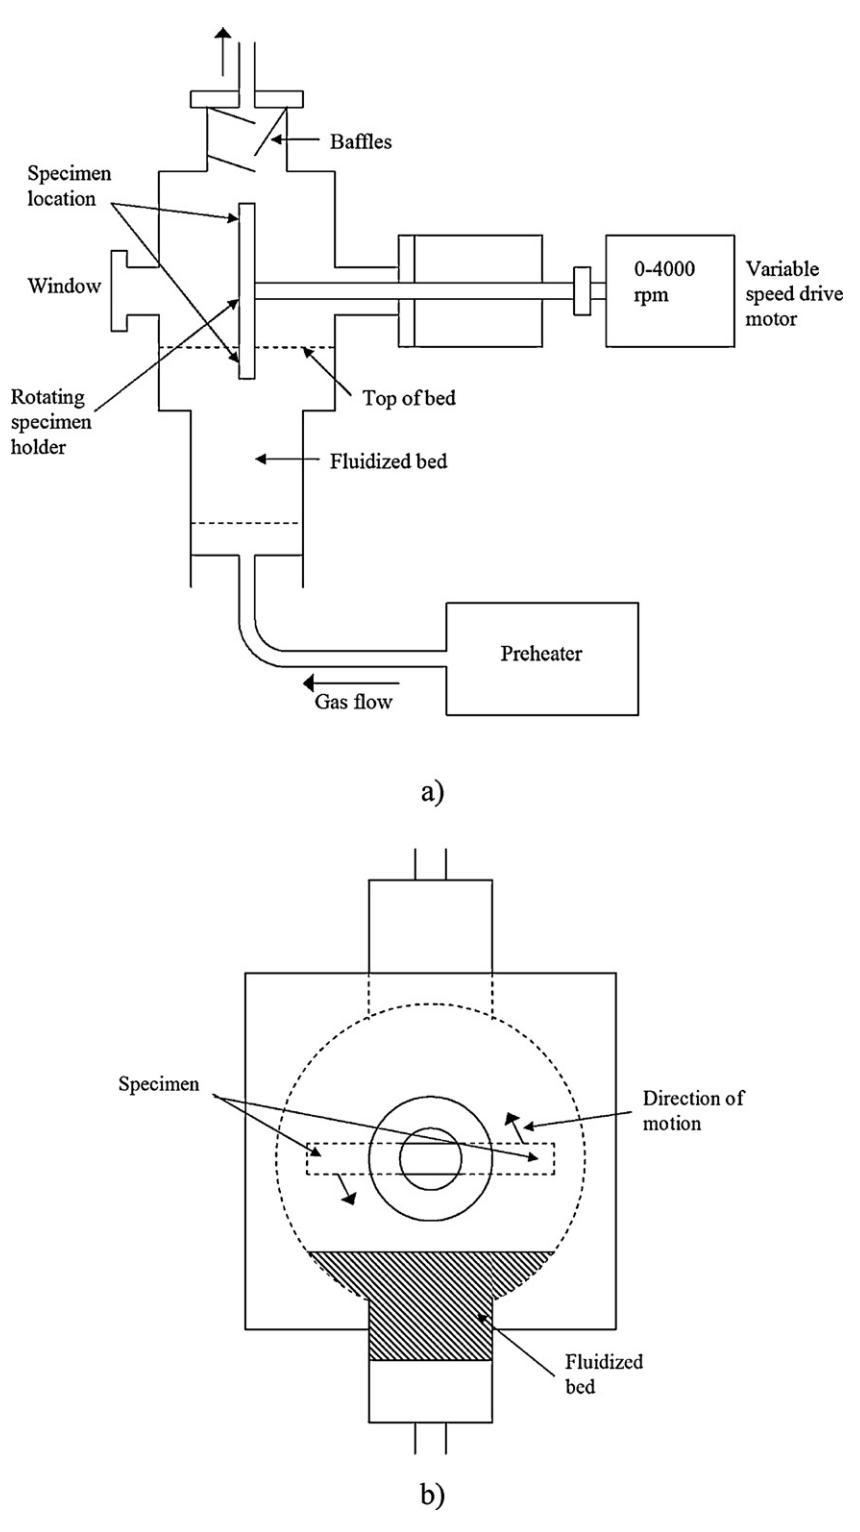
Fig. 1. Schematic diagram of the fluidized-bed rig. (a) Side view. (b) Front view.

Isothermal elevated-temperature erosion-oxidation tests were carried out in a whirling arm fluidized-bed rig (Fig. 1) under conditions summarized in Table 1. The rig consists of a fluidized bed with 40 vol.% particles, a heating system and a specimen-holder assembly. The heating system has three independent heating zones which maintain the air entering the bed of particles, the bed itself and the specimen all at the same temperature. During operation, air is pumped through the heated spiral flow tube, enabling it to attain the necessary acceleration in addition to the set temperature before entering the bed. The specimens are fastened in two holders that are located at each end of the specimen arm and fixed at desired impact angles with respect to the bed of particles. The specimen arm is rotated through the fluidized particle bed by a drive motor, the rotational speed of which is adjusted to a desired value using a speed counter. The adjustment of the rotational speed enables constant linear speeds between the specimens and the particles to be obtained. Hence, in this study, the specimens move with respect to the bed of particles: the arm is designed to allow the attached specimens to impact the bed of particles at a constant angle, to be completely immersed in the bed at the lowest point and then to move through the space above the bed. Each location of the specimens travels a different distance during one rotation of the arm, giving a particular linear speed between the specimen at each location and the bed particles. During the tests, the back side and the edges of each specimen were protected by the holder, exposing only the front surface to the impacting particles.

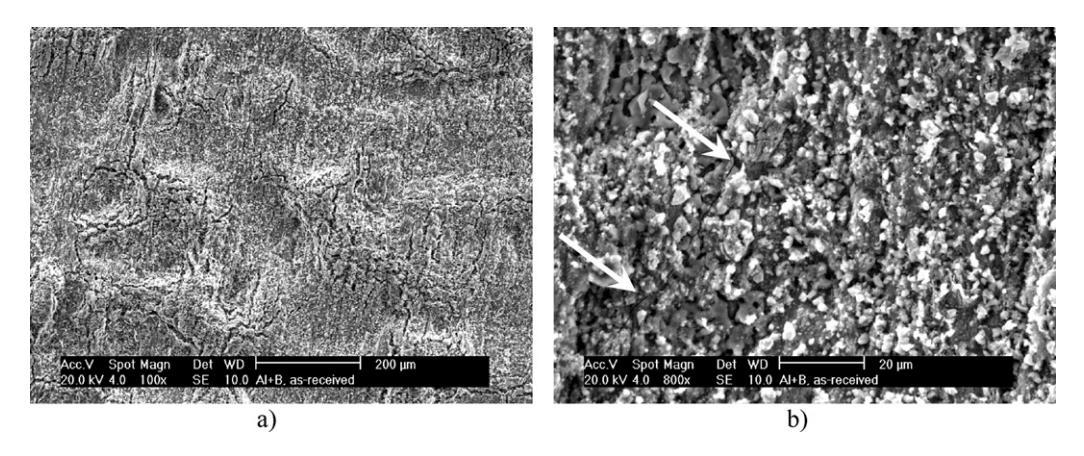
Fig. 2. SEM images, showing the surface of aluminized specimens. (a) A wavy surface topography. (b) Structure in more detail. In (b), the arrows point out a crack.

SEM examination on the surface of aluminized coating revealed a wavy surface contour with evident hills and valleys (Fig. 2a), although there were also more uniform areas. Some cracks were evident on the coating surface (Fig. 2b), consistent with literature [8]. When studied in cross section, several phases were detected in the coating (Fig. 3). The outermost coating layer comprised of the major aluminium-rich phase (Fig. 3a and b, Table 2) and of two embedded phases: a chromium-rich phase, seen light in SEM BSE images (Fig. 3a and d), and a precipitate phase that appeared dark in SEM BSE examination (Fig. 3c and d). EDS analyses of the dark precipitates by FE-SEM indicated them to contain much nitrogen and less iron and chromium as compared to the other coating phases (Table 2), suggesting they might be AIN. The dark precipitate phase was concentrated on the inner half of the coating, i.e., closer to the substrate, whereas the lighter phase embedded in the coating matrix was relatively evenly distributed throughout the coating thickness. Underneath the outermost coating layer, an inter-metallic layer was detected, with decreased aluminium and increased iron content as compared to the outermost layer. In the substrate, aluminium- and nitrogen-rich, needle-like precipitates were detected down to the depth of about 30 µm below the original surface (indicated by an arrow in Fig. 3a). Also these were probably AlN, consistent with the results by Agüero et al. [18].

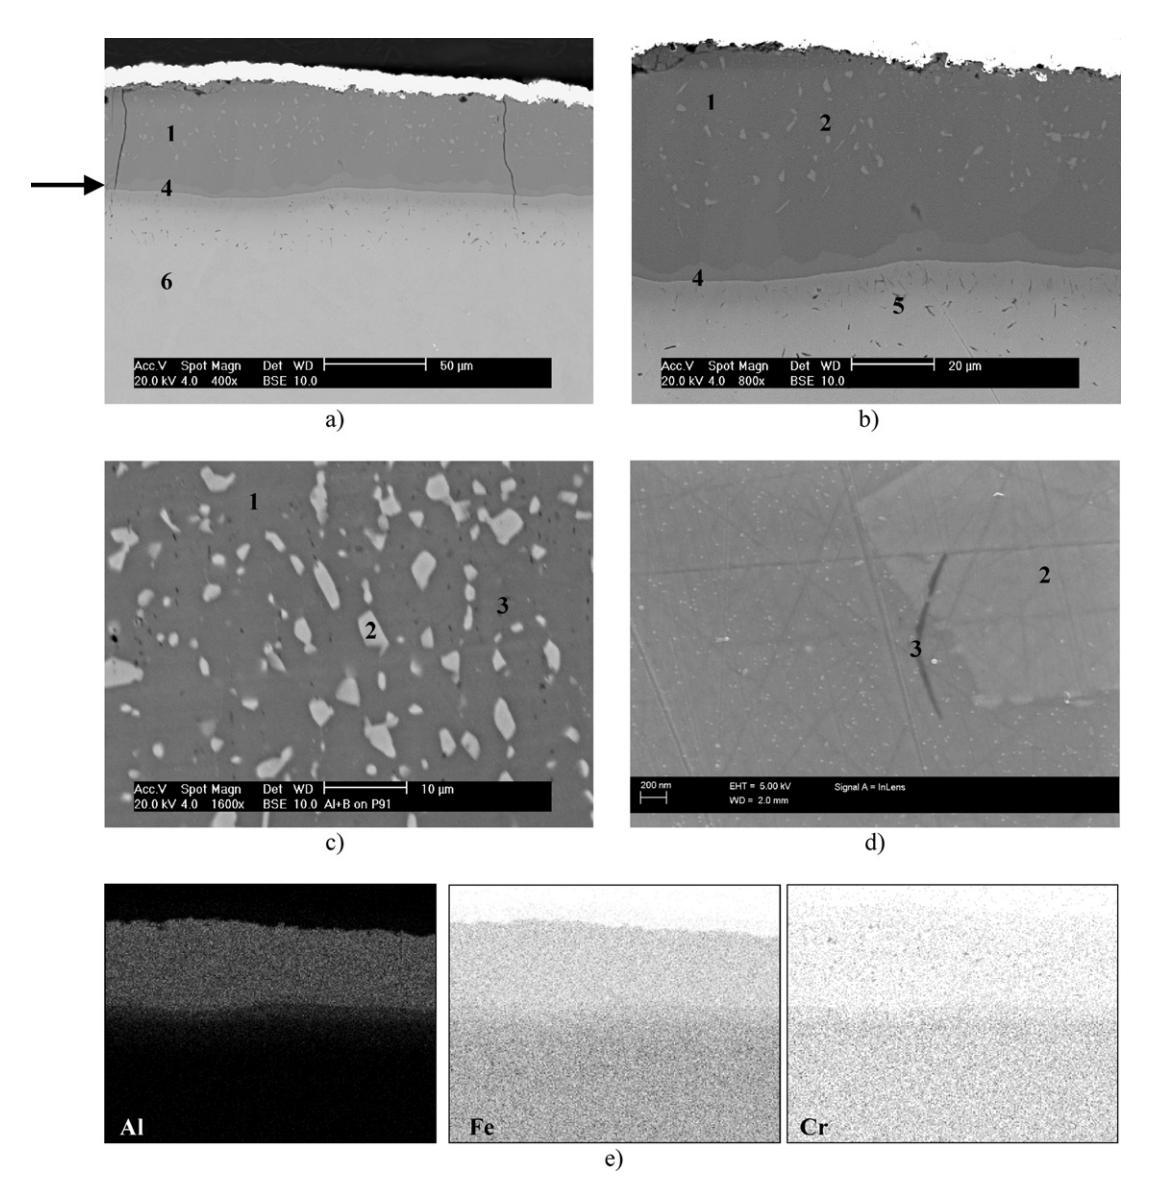
Fig. 3. SEM images of cross section of the aluminized specimens. (a), (b) A general view. (c) A more detailed view of the outermost coating layer. (d) FE-SEM image, showing the coating phases in more detail. (e) Elemental maps of the area shown in (a). Different phases are indicated by numbers (1–6) and their compositions are given in Table 1.

significance for the behaviour in erosion-oxidation test. Further, microstructural changes within the substrate, i.e., the presence of the AlN precipitates, reached a depth of about 20–30 μ m below the original steel surface (Fig. 3). Fig. 5 shows the results from

Composition, in at,%, of various phases present in aluminized specimens and indicated by numbers (1–6) in Fig. 3a–d. The last column shows the phase structure, as deduced from composition and XRD analyses. Also hardness values for the phases are given.

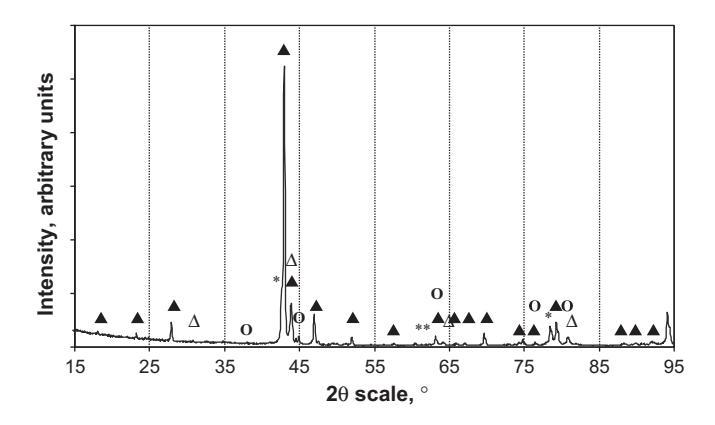
Fig. 4. XRD spectrum for the aluminized specimen. \blacktriangle Denotes the Al₅Fe₂ phase, \triangle denotes the AlFe phase, * denotes the AlCr₂ phase and O denotes the AlN phase.

Results from XRD measurements (Fig. 4) disclosed the presence of the Al_5Fe_2 , AlFe, AlCr₂ and AlN phases. Many of the peaks related

to the four detected phases overlapped, but in all cases, there was at least one clear peak that is characteristic of each phase. In addition, in each case, all major peaks appeared in the XRD spectrum. High intensities of the peaks related to the Al₅Fe₂ phase indicated it to be the major coating phase, consistent with SEM studies and EDS analyses. The AlFe phase, the peaks of which were also detected in the XRD spectrum, relatively well corresponded in composition to the layer detected at the coating-substrate interface in SEM and EDS examinations. The chromium-rich precipitate phase was likely

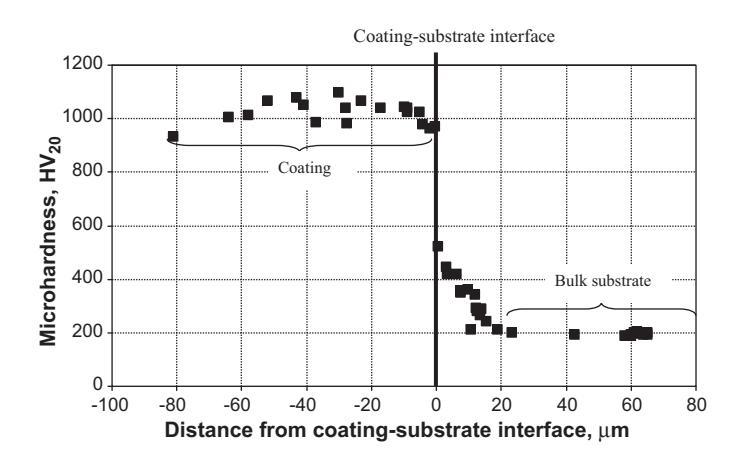
Fig. 5. Microhardness values, determined in cross-sectional specimens at various distances from the coating-substrate interface.

microhardness measurements at various distances from the coating-substrate interface. Microhardness values for the coating were high, typically in the range from 950 to 1100 HV. These values are similar in magnitude to those that we have measured for the aluminized coatings on the same substrate material, i.e., for the Al₅Fe₂ coating. Hardness values for the various phases and the substrate are given in Table 2. However, here, the AlN precipitates in the coating were much smaller than the indentation following the measurements, indicating that their contribution to the measured microhardness values is negligible. It is, nevertheless, good to bear in mind that metal nitrides are very hard, typically in the range from 1150 to 2200 HV [16]. At the coating-substrate interface, the microhardness values sharply decreased to a value of 520 HV and then, gradually within the AlN precipitate zone, to about 200 HV that was measured for the substrate. Again, the AlN precipitates

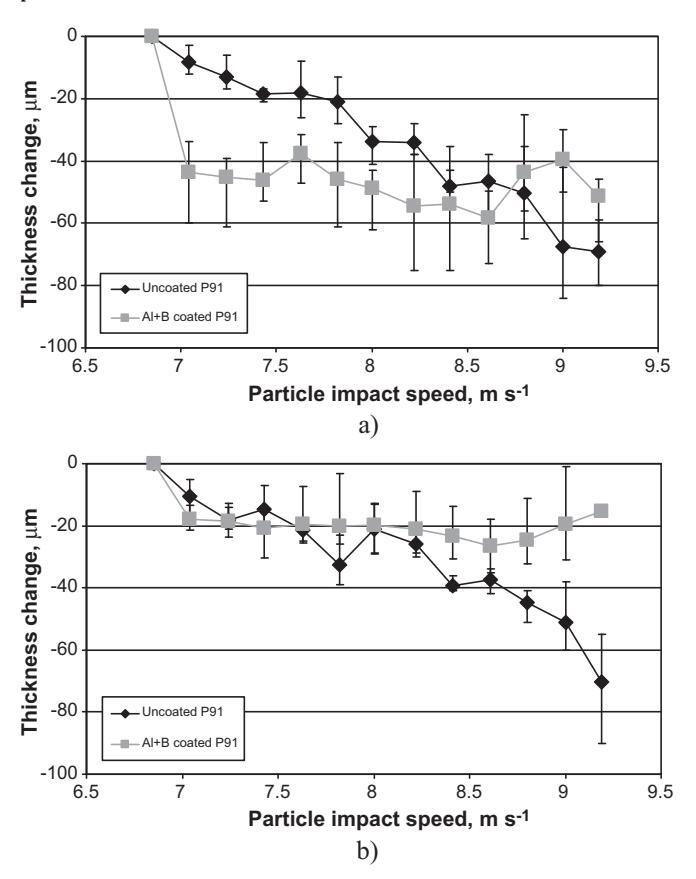
Fig. 6. Mean thickness changes for the specimens exposed at $550 \degree C$ under particle impacts at two impact angles. (a) $30\degree$. (b) $90\degree$.

Figs. 6–9 show thickness changes for aluminized and, for comparison, uncoated specimens after erosion-oxidation tests at 550, 600, 650 and 700 °C under particle impacts at the angles of 30 and 90° as a function of particle impact speed. At 550 °C, under particle impacts at 30°, the mean thickness losses for aluminized specimens were in the range from 40 to 60 μ m at all speeds, with no clear dependence of the magnitude of losses on particle speed being detected (Fig. 6a). For comparison, thickness losses for uncoated specimens evidently increased with increase in speed, reaching a loss of about 70 μ m at the highest speeds. At 550 °C, at an angle of 90°, the mean thickness losses for aluminized specimens were

about 20 μ m at all speeds, while those for uncoated specimens increased almost linearly with increase in speed, up to about 70 μ m at the highest speed (Fig. 6b).

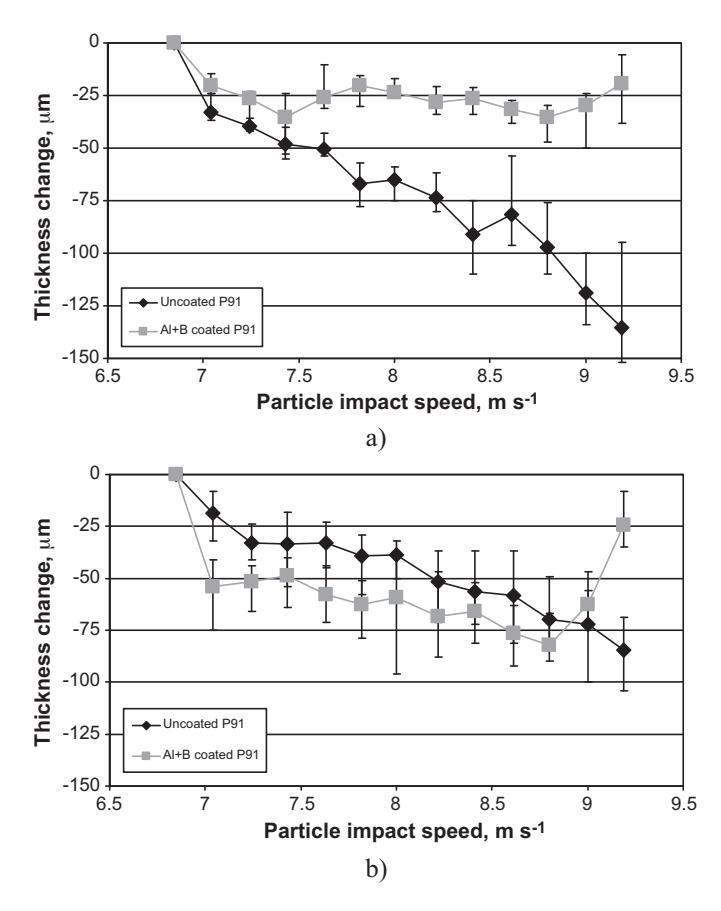
Fig. 7. Mean thickness changes for the specimens exposed at $600 \degree C$ under particle impacts at two impact angles. (a) $30\degree$. (b) $90\degree$.

At 600 °C, at an angle of 30°, the mean thickness losses rang-ing from 20 to 35 μ m were recorded for aluminized specimens independently of particle travel speed (Fig. 7a). Again, the corresponding losses for uncoated specimens increased with increase in particle speed, giving the maximum loss of 135 μ m at the high-est speed. Under 90° impacts, the thickness losses for aluminized specimens were the highest among recorded in this study, varying typically in the range from 50 to 85 μ m (Fig. 7b). Although the magnitude of losses slightly increased with increase in speed from 7 to 8.8 m s⁻¹, further increases in speed introduced signifi-cant decrease in thickness losses. In the case of uncoated specimens, a linear increase in the magnitude of thickness losses with increase in particle speed was apparent, again, with the maximum loss being about 85 μ m.

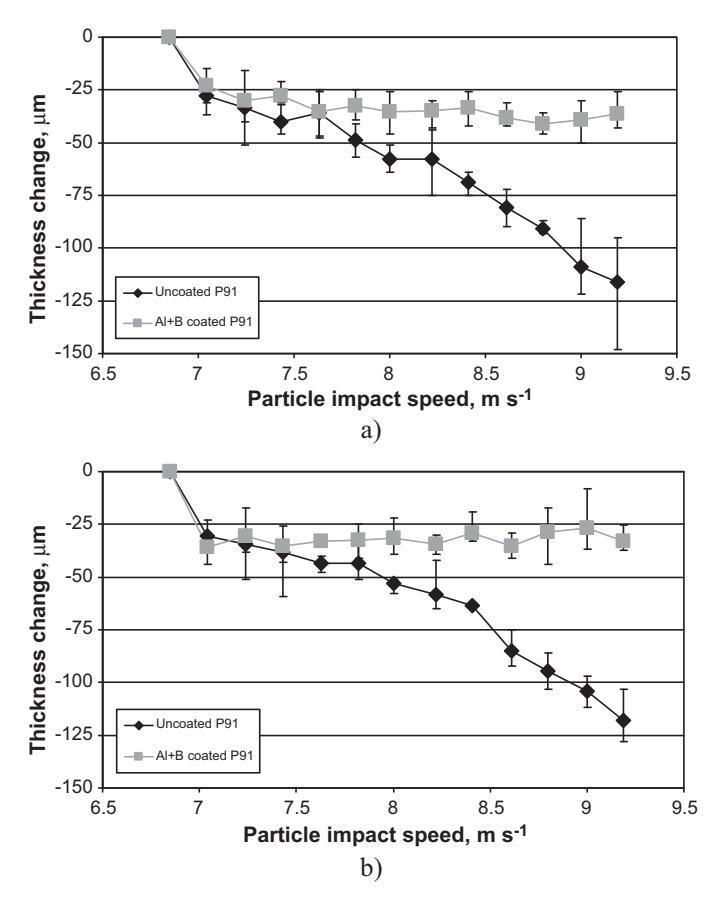
Fig. 8. Mean thickness changes for the specimens exposed at $650 \degree C$ under particle impacts at two impact angles. (a) $30\degree$. (b) $90\degree$.

At 650 °C, the behaviour for both types of specimens, coated and uncoated, was independent of impact angle, with lower thickness losses being obtained for coated specimens (Fig. 8a and b). In the case of aluminized specimens, the mean thickness losses under par-ticle impacts at both 30 and 90° were in the range from 25 to 35 μ m at all speeds, i.e., independent of particle impact speed. In contrast, in the case of uncoated specimens, the thickness losses increased steadily with increase in particle speed, up to a loss of 115 μ m at the maximum speed, at both angles.

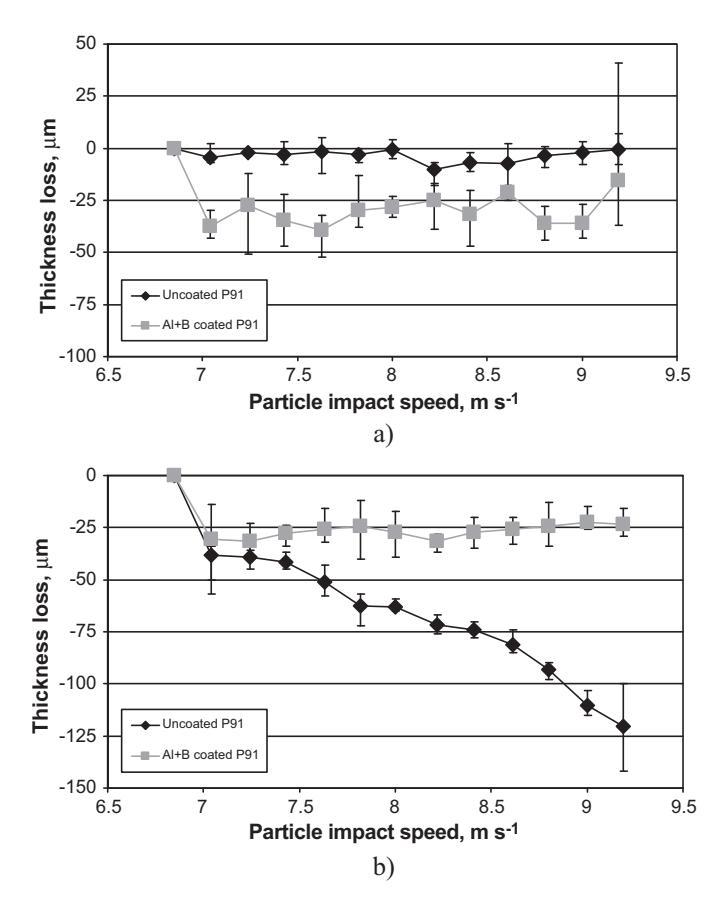
Fig. 9. Mean thickness changes for the specimens exposed at 700 $^{\circ}$ C under particle impacts at two impact angles. (a) 30 $^{\circ}$. (b) 90 $^{\circ}$.

At 700 °C, at an angle of 30°, the mean thickness losses for aluminized specimens varied from about 20–40 μ m in magnitude at all speeds and were evidently much greater than those for uncoated specimens that varied in the range from 0 to 10 μ m in magnitude at all speeds (Fig. 9a). At an angle of 90°, conversely, the mean

thickness losses for aluminized specimens were only from 20 to $35 \,\mu$ m in magnitude, irrespective of particle speed, whereas the corresponding losses for uncoated specimens essentially increased with increase in speed, yielding the maximum loss of about 120 μ m at the highest speed (Fig. 9b).

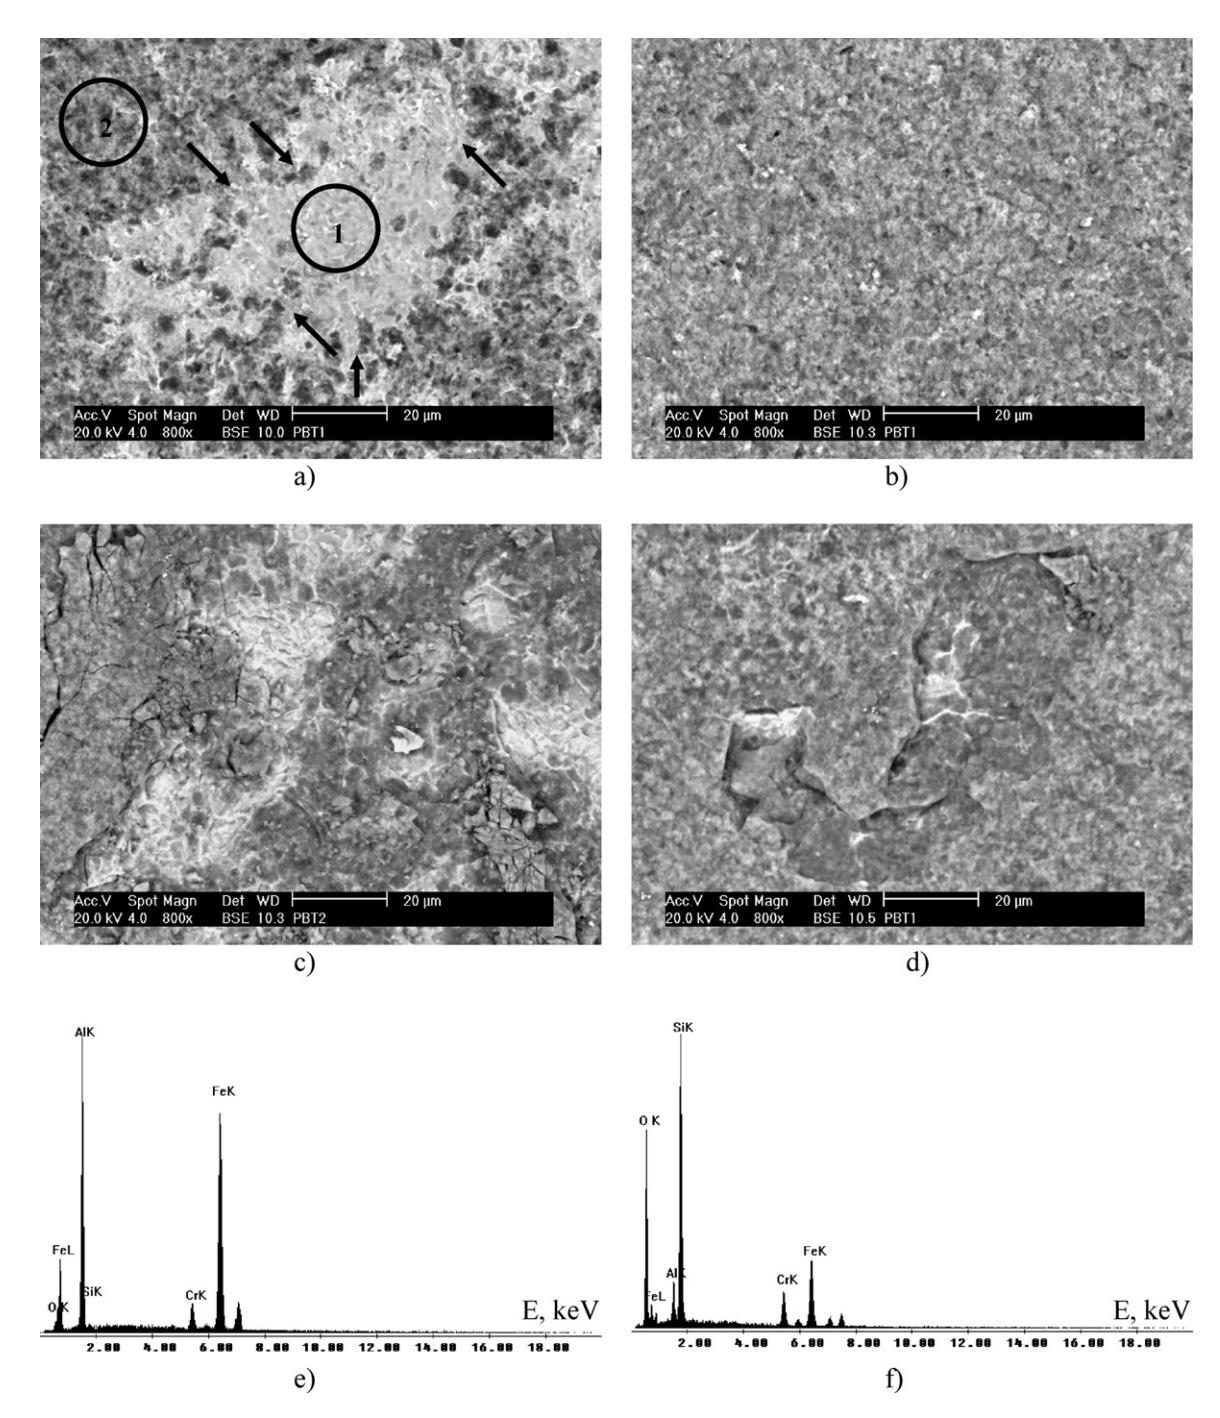
Fig. 10. SEM images and EDS analyses of surface of the specimens exposed at 550 °C under several conditions. (a) 30°, 7 m s⁻¹. (b) 30°, 9 m s⁻¹. (c) 90°, 7 m s⁻¹. (d) 90°, 9 m s⁻¹. (e) EDS spectrum corresponding to area 1, indicated in (a). (f) EDS spectrum corresponding to area 2, indicated in (a).

SEM examination on exposed surfaces revealed that the sand particle debris was deposited on the surfaces, forming a homogeneous and an almost continuous layer (Figs. 10-11), instead of a heterogeneous composite coating together with the exposed alloy and the oxide scale on it, more typically encountered during combined erosion-oxidation. However, SEM studies showed that there were slight differences in the continuity of the particle debris layer between test conditions, especially between particle travel speeds and impact angles. At the lowest speeds, the particle debris layer was evidently less continuous than at the highest speeds, with areas of a bare aluminized coating (without deposited sand particle debris) being occasionally detected at the lowest speeds but much less frequently and at much smaller size than at the highest speeds. Furthermore, typically, at an angle of 30°, the surfaces were smooth and the uncovered areas of the coating contained some wear scars (Figs. 10a and 11a) as a result of a cutting type of wear. At an angle of 90°, in contrast, the surfaces were more irregular, with cracking of both the aluminized coating and, particularly, the sand debris layer, being evident (Figs. 10c,d and 11c). No appar-ent trend between nature of the exposed surfaces and temperature was detected. It is, further, emphasized that since erosion evidently played a key role in behaviour of the surfaces, no indications of oxi-dation could be detected. Therefore, the primary damage mode of

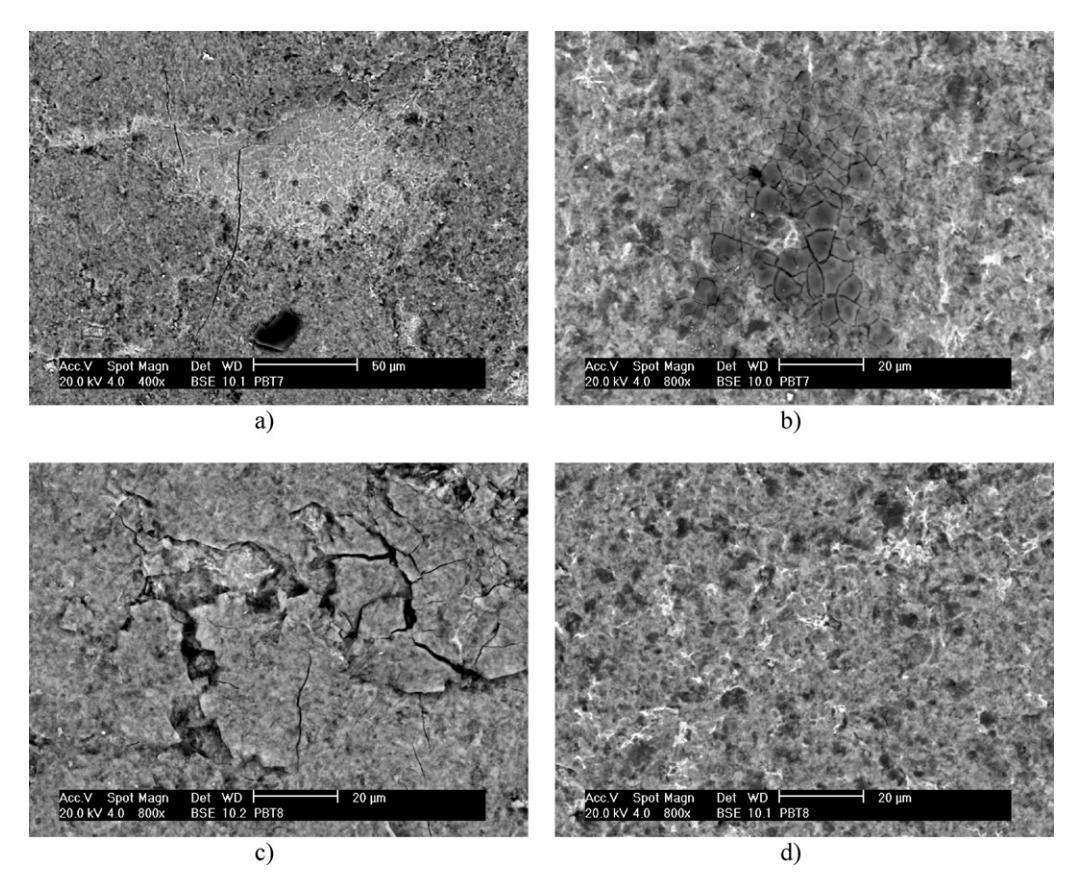
Fig. 11. SEM images of surface of the specimens exposed at 700 °C under several conditions. (a) 30°, 7 m s⁻¹. (b) 30°, 9 m s⁻¹. (c) 90°, 7 m s⁻¹. (d) 90°, 9 m s⁻¹.

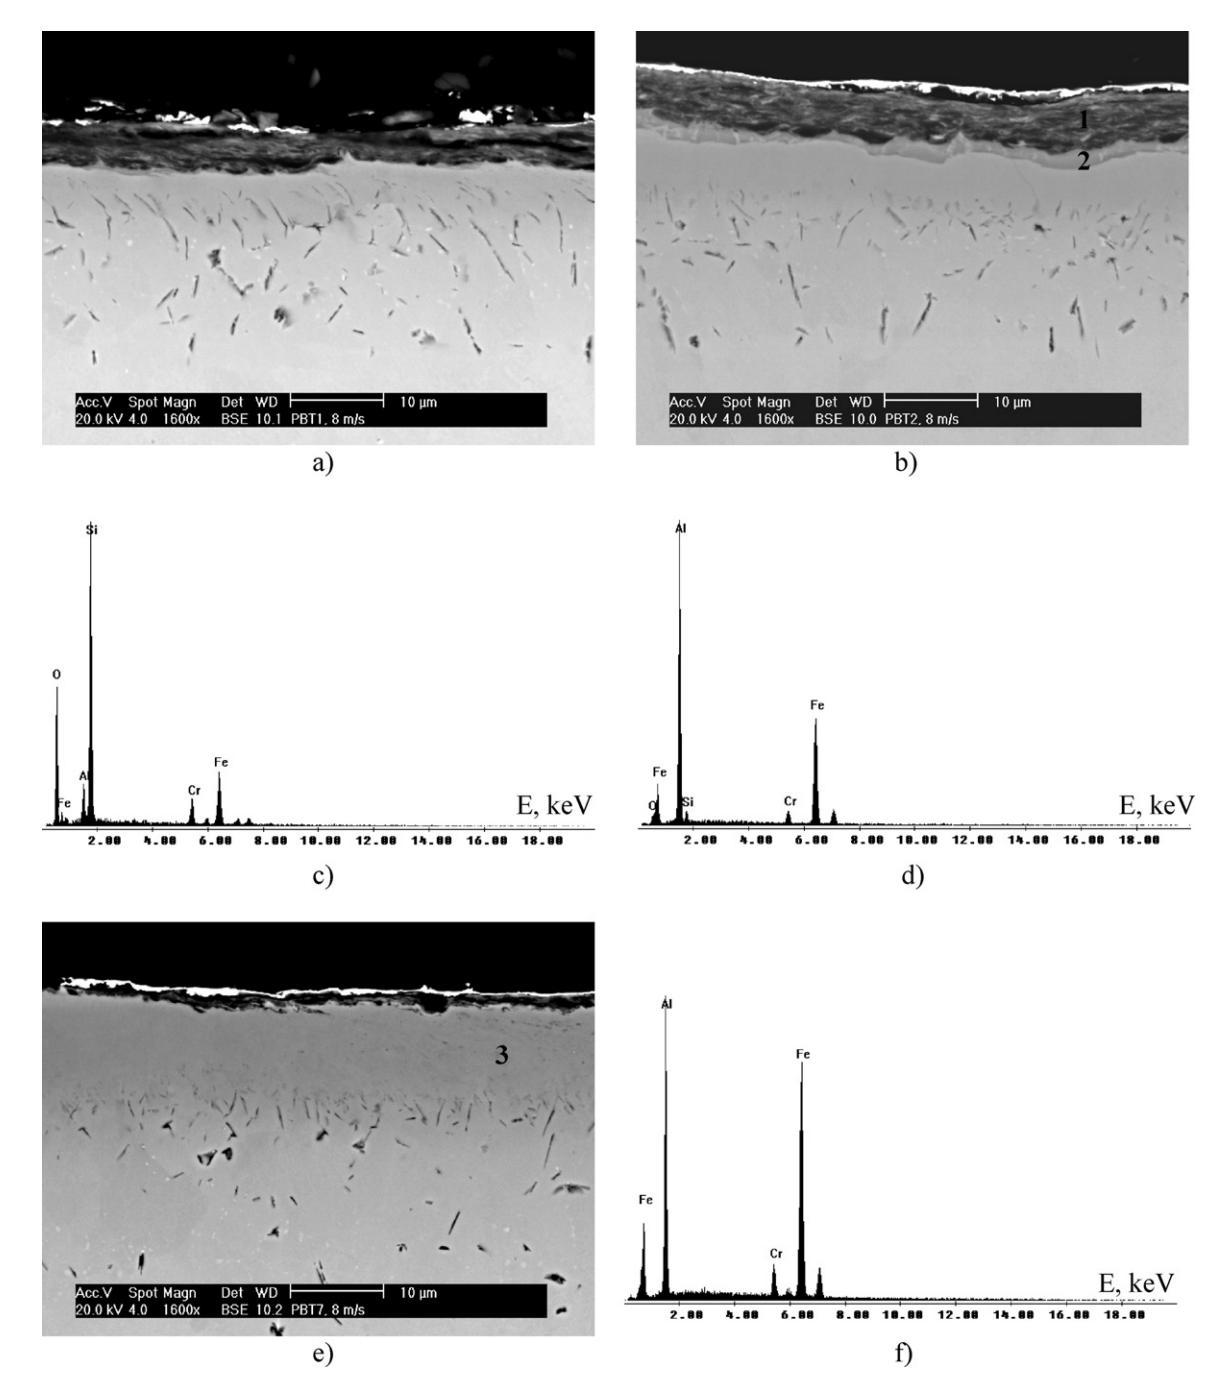
Fig. 12. SEM images and EDS analyses of cross sections of exposed specimens. (a) $550 \degree C$, $30\degree$, $8 m s^{-1}$. (b) $550 \degree C$, $90\degree$, $8 m s^{-1}$. (c) EDS spectrum corresponding to area 1, indicated in (b). (d) EDS spectrum corresponding to area 2, indicated in (b). (e) $700\degree C$, $30\degree$, $8 m s^{-1}$. (f) EDS spectrum corresponding to area 3, indicated in (e).

Cross-sectional study on exposed specimens (Fig. 12) disclosed that the homogeneous layer on the specimen surfaces primarily contained debris of the sand particles but also some remnants of the coating. Such layer was detected all over the exposed surfaces, with the thickness being typically of the order of some micrometres. In all cases, some of the outermost Al-rich coating layer was retained under the sand particle debris layer although it was relatively thin, even less than a micrometer in thickness, particularly at the lowest temperatures. Furthermore, cross-sectional study revealed that various coating layers and their interfaces were not as evident as before the tests, indicating that some diffusion might have taken place. It is also worth mentioning that after the tests at the lowest temperatures, composition of the retained coating corresponded to the Al₅Fe₂ phase, whereas after the tests at the highest temperature, it corresponded essentially to the FeAl phase. The AlN precipitates were evident in the substrate in all cases.
