Álvarez, S., Bautista, A., Velasco, F. (2013). Influence of process parameters on the corrosion resistance of corrugated austenitic and duplex stainless steels. *Materials and Technology*, vol. 47, no. 3, pp. 317-321. Available in <http://mit.imt.si/Revija/izvodi/mit133/alvarez.pdf>.

INFLUENCE OF PROCESS PARAMETERS ON THE CORROSION RESISTANCE OF CORRUGATED AUSTENITIC AND DUPLEX STAINLESS STEELS

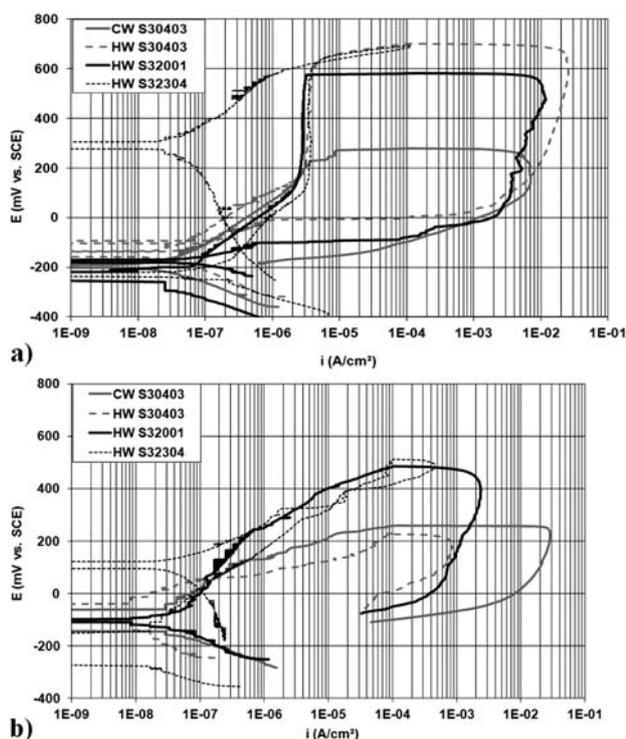
The polarization curves of the corrugated surfaces and the centres of the stainless-steel bars clearly exhibit different shapes, as can be seen in **Figure 1**, where the curves corresponding to the non-carbonated solutions with 5 % NaCl are shown. For the samples without corrugations (**Figure 1a**), the pitting potential (E_{pit}) is well defined and corresponds with very sharp current increases. On the other hand, in the tests carried out on the real surfaces of the bars (**Figure 1b**), the current increase after E_{pit} is less pronounced. It must be pointed out that on certain materials exposed to particular testing conditions, no corrosion occurred during the test. This is the case, for example, of the centre of the HW S32304 bar in a non-carbonated solution with 5 % NaCl (**Figure 1a**), where the current increase does not correspond to any corrosion phenomenon but it is due to the water decomposition through reaction 1:

Figure 1: Polarization curves in non-carbonated $\text{Ca}(\text{OH})_2$ solutions with 5 % NaCl: a) centres of the bars, b) corrugated surfaces

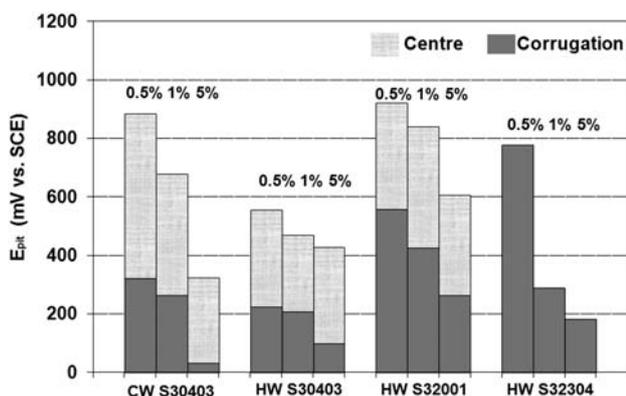
It is very interesting to find a significant decrease in the corrosion resistance of the bars due to the changes to the corrugations taking place during the forming process. Figure 2 shows the difference between the E_{pit} values of the studied stainless steels in carbonated solutions, with the measurements carried out on the corrugated surfaces

Figure 2: Differences between the E_{pit} measured in the centres of stainless-steel bars and on corrugated surfaces in carbonated $\text{Ca}(\text{OH})_2$ solutions with different chloride contents

In the carbonated solutions without chlorides, no corrosion was detected for any of the studied stainless steels. Moreover, the centres of the HW S32304 bars proved to be immune to corrosion during the polarization tests carried out independently of the chloride content of the carbonated solution. However, during the polarization of the corrugated surfaces of HW S32304 in the presence of chlorides, current increases corresponding to a corrosive attack were detected, even with 0.5 % NaCl.

For the other three studied stainless-steel grades, a localized corrosion always occurred during the polarization tests in the carbonated solutions with chlorides.

For all the materials the E_{pit} of the corrugated surface is much lower than the E_{pit} of the centre of a bar.

As expected, in all the cases an increase in the chloride content of the solution causes a decrease in the resistance to localized corrosion, i.e., a decrease in E_{pit} .

If the results from **Figures 2** and **3** are used to compare the corrosion behaviours of different grades, it is demonstrated that HW S32304 is clearly more corrosion resistant than any of the studied austenitic grades. Despite the volatility of the prices in the market, it can be considered that a S32304 grade can cost about 9 % less than a S30403 grade. This result justifies the great interest in this DSS grade that is seen as an alternative for the traditional austenitic grade used in these applications, as S32304 has a better performance and it is somewhat more economical. The DSS S32001 grade can be estimated to be about 15 % cheaper than the austenitic S30403. The results of the corrosion tests

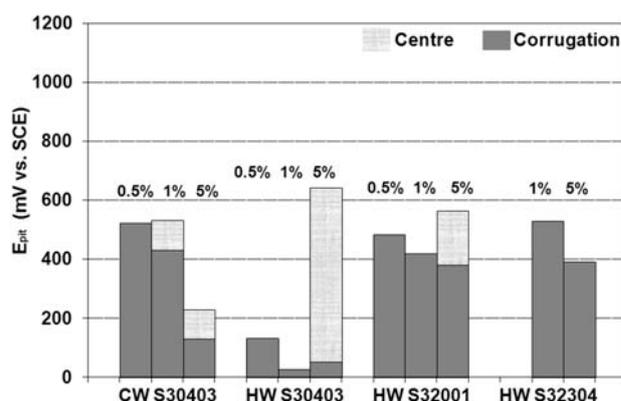
Figure 3: Differences between the E_{pit} measured for the centres of stainless-steel bars and for the corrugated surfaces in non-carbonated $\text{Ca}(\text{OH})_2$ solutions with different chloride contents. Conditions without the plotted E_{pit} values correspond to tests where no corrosion takes place.

In **Figure 3**, the E_{pit} values detected in non-carbonated solutions are plotted. It can be seen that, at a higher pH, it is more difficult to cause corrosion during the test. In the solutions without chlorides, no corrosion occurs in any of the cases and the centre of HW S32304 is immune to the attacks in the testing media with chlorides, as reported for $\text{pH} \approx 9$. Besides, no corrosion occurs during the polarization in the solutions with 0.5 % NaCl on the centres of the other studied bars. In the case of the 1 % NaCl testing solution, no corrosion was found on the centres of HW S30403 or HW S32001.

The corrugated surfaces of the bars prove again to be much more prone to corrosion. For this type of samples, the only condition where no pitting is detected is HW S32304 with 0.5 % NaCl. The important influence of the microstructural changes occurring in the surfaces of the corrugated bars during the forming process is again clearly proved.

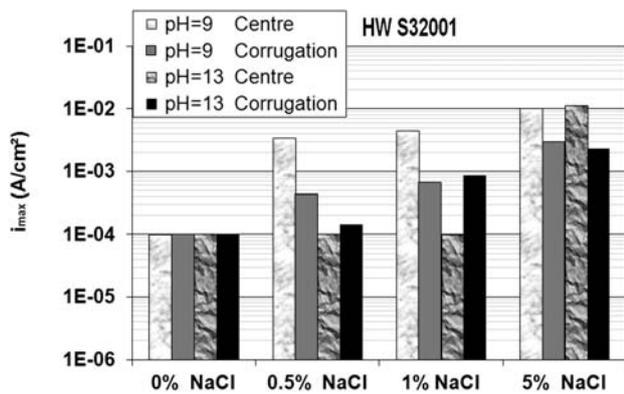
Figure 4: Differences between the i_{max} values obtained with the polarization curves for the centres and the corrugated surfaces of duplex HW S32001 bars in carbonated and non-carbonated $\text{Ca}(\text{OH})_2$ solutions with different chloride contents

In addition to E_{pit} , another interesting parameter, which can be obtained from the polarization curves, is the maximum intensity (i_{max}) reached during the measurements. All the curves are programmed to reverse the potential sweep when a current intensity of 10^{-4} A/cm² is reached. When no corrosion occurs, i_{max} is 10^{-4} A/cm², as the current quickly decreases when the applied potentials decrease. When pits are formed during the anodic polarization, the current still increases as the potentials start to decrease due to the important autocatalytic effect of the localized corrosion. The higher the i_{max} , the more dangerous is the pitting morphology. As an example, the values of this parameter for sixteen tested conditions of HW S32001 were plotted in **Figure 4**. If the conditions, under which no corrosion takes

place, are not considered (0 % NaCl and the centre of the bar for 0.5 and 1 % NaCl at pH \approx 13), it can be seen that the samples from the centre of the bar, though less susceptible to corrosion than the corrugated surfaces, suffer from a more aggressive attack than when it occurs on the surface. The same conclusion is reached if the results for the other four studied materials are analyzed. It can also be seen in **Figure 4** that chlorides have an important influence on the increase of i_{\max} .

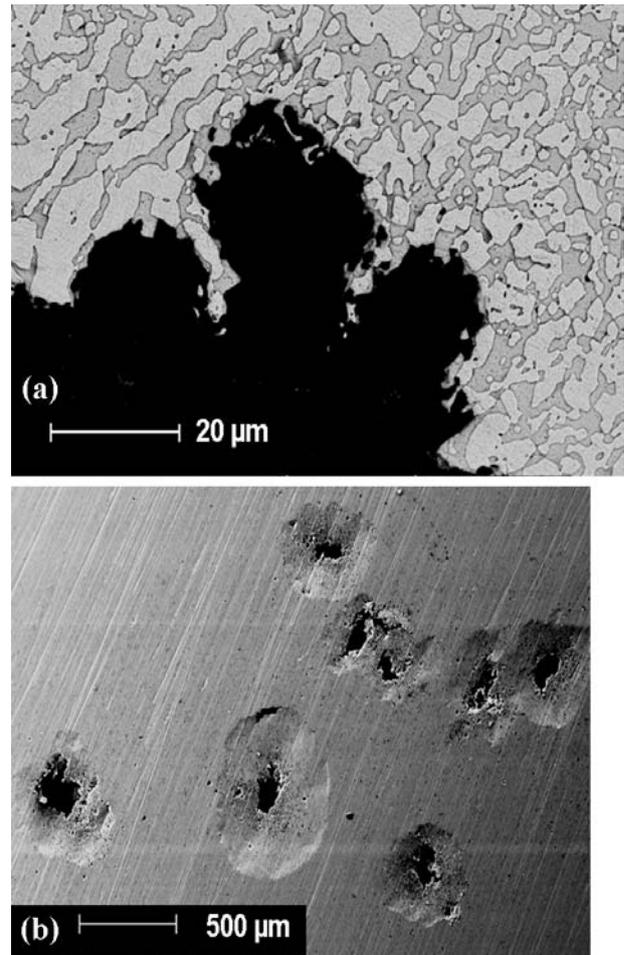
Figure 5: Images of different morphologies of the attacks that appear on the centre of a bar and on the corrugated surface. The pits after the polarization of HW S32001 in non-carbonated $\text{Ca}(\text{OH})_2$ solutions with 5 % NaCl: a) corrugated surface, b) center of the bar.

An observation of the morphology of the pits after the polarization curves confirms the idea deduced from the i_{\max} values. As it can be seen in **Figure 5**, the polarization causes small, shallow pits widely distributed on the most deformed regions of the surface of the corrugation. In the centre of the bar, polarizations cause scarce, but much bigger pits that can be much more dangerous.

The attack that appears on the corrugated surfaces of stainless steels during an anodic polarization is less localized and less dangerous than the attack that appears in the centres of the bars.
